Luston Group Parish Council

**Flood Alleviation Recommendations,
Luston,
Herefordshire**

**Report LL0058
December 2021**

**Prepared and submitted by
Lidar-Logic**

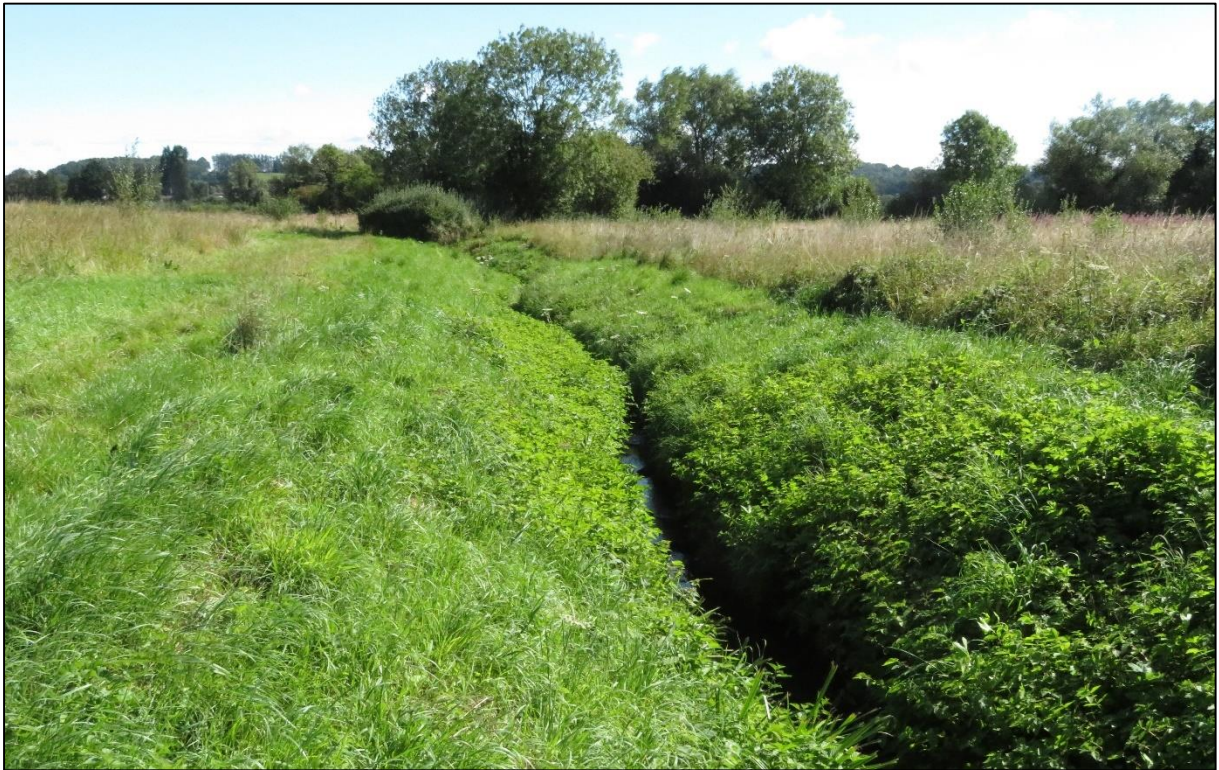
Figure 15 Luston Brook upstream of the village, looking west

Luston brook flows easterly as an open channel towards the village (Figure 15), it passes through culverts beneath field entrances (Figure 16). In the open-channel sections there is significant in-channel vegetation with some area of recent vegetation clearance. In sections of the floodplain there is uncontrolled vegetation growing along stretched of the floodplain, as seen from the Primary School grounds, in Figure 17.

Local channel features that influence conveyance can include in-channel debris, which can reduce the channel capacity to convey flow, this reduced conveyance capacity, increases water levels for a given flow. Surface roughness provides the primary resistance to the flow in the absence of blockage. In-channel vegetation will result in greater resistance, slowing flow and increase water levels. Excessive in-channel and floodplain vegetation growth can promote sedimentation accumulation within the channel leading to significant loss of conveyance and raise upstream water levels.

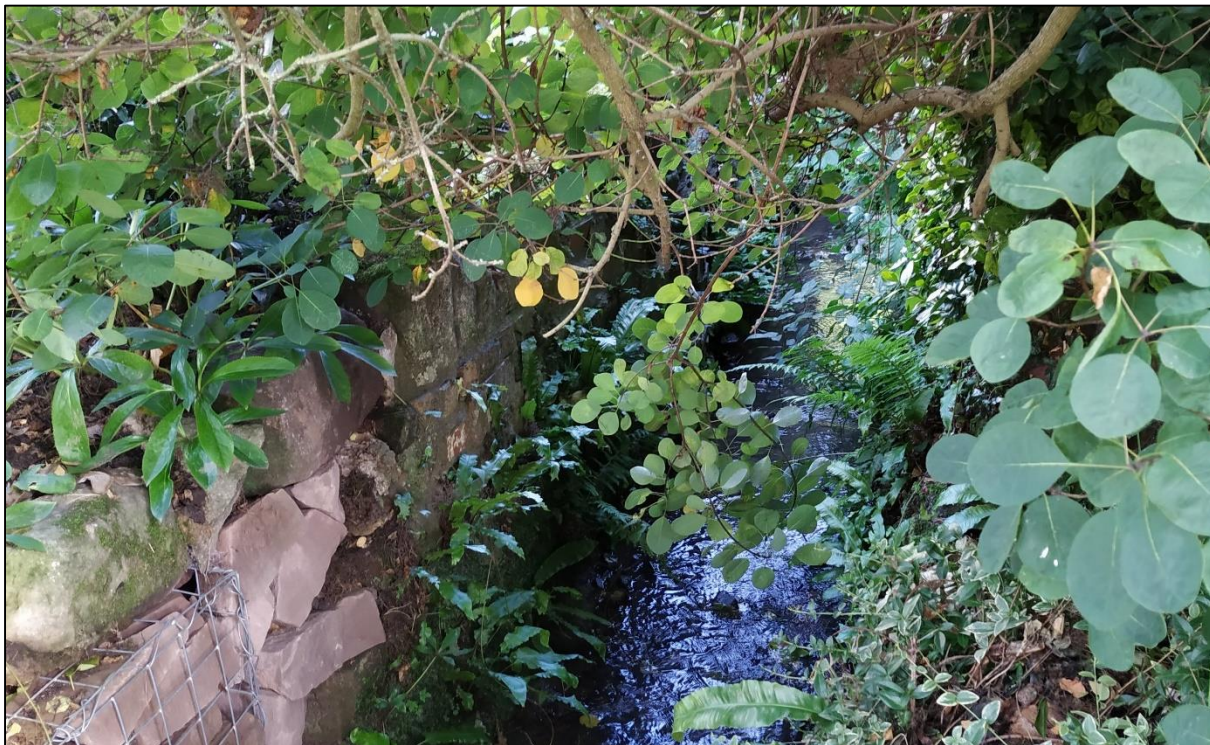
Figure 18 Luston Brook channel constriction upstream of culvert

The brook flows south of Townsend Park and along the northern boundary of Luston Primary School. As the brook flows into the village, the channel is constricted between property boundaries (Figure 18). Near-vertical channel walls are formed of rock aggregate, held in place by steel wire and known as “Gabion baskets”. At this location, about 50 m upstream of the B4361 road culvert, they reduce the channel to approximately 1.2 m x 1.2 m (Figure 19).

Description: 1) In order to increase capacity and conveyance of flood flows along Luston Brook, it is recommended that channel improvements are made upstream of the culvert and between two properties. The channel at this point is constricted to a width of 1.2 m by stone banks (Figure 18) and it is recommended that the channel width along this stretch is increased to remove this local constriction. The channel dimensions should be similar to the channel downstream of the culvert, to manage rising water levels and allow flood flows to flow freely downstream towards the culvert. 2) Another measure that should be considered in conjunction with the upstream channel width increases, is the removal of the sharp bend within the channel, downstream of the culvert. Flow leaving the culvert follows a convoluted course, being diverted by a stone wall, as shown in Figure 22. This flow route impedes conveyance during a flood event and will increase flood levels upstream. Replacement of the stone walls with a structure that is better aligned with flow would help maintain the downstream velocity of the floodwater.

- 1) Remove the obstacle in the channel at the downstream end of the road culvert and replace the bank at that point with less intrusive and better-contoured support.
- 2) Widen the channel immediately upstream of the culvert, in order to provide adequate conveyance into the culvert and mitigate overbank flow at that point.

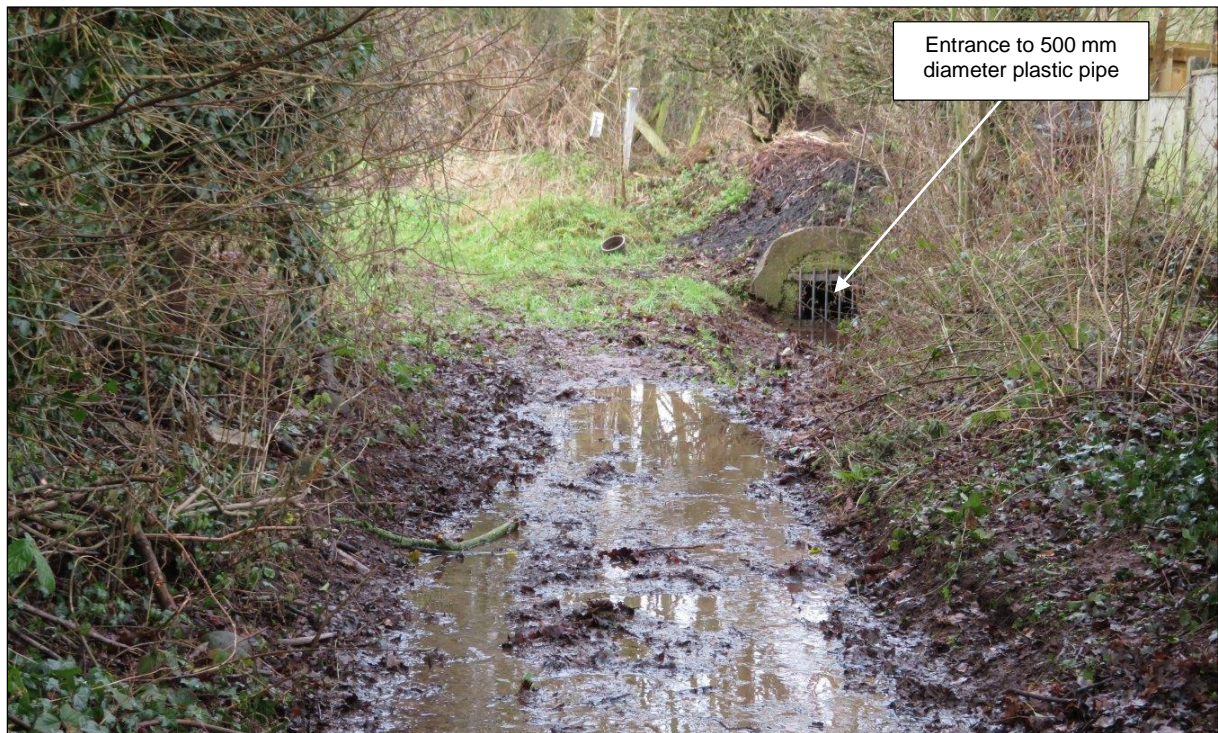
Figure 28 View to the north west, along the footpath mapped in Figure 26

There is evidence of an attempt to mitigate flood risk in the past. A 500 mm diameter plastic pipe has been laid through the school grounds, near their south western boundary. Flow can enter the pipe near the end of the footpath shown in Figure 25, to the right of the alleyway in Figure 27. As shown in Figure 28, a trash screen has been fixed across the entrance to this pipe, although leaf litter and other small detritus is presumably able to enter.

Having reached the location to the south west of the school, where a 500 mm pipe is in place to convey floodwater to the western limit of the school grounds, it is recommended that the current system is modified. Low rates of flow along the footpath, such as that shown during January 2021 (Figure 25) can probably be managed by the existing system. The purpose of this pipe however is to manage moderate to high flow rates and protect the school from future flooding. In this regard, the pipe has failed once and although discharge along the footpath is expected to be reduced by the recommended alleviation channel, there remains the possibility of future blockage, within the pipe or at its entrance.

Closed pipes are inherently unsuitable for tasks such as this and an open ditch is the recommended alternative. Although the route of the pipe could not be traced, it clearly conveys flow, as evidenced by the limited outflow in January 2021 (Figure 29). If it were removed, it should be possible to construct an open ditch along that same route. The first part of the ditch would need to pass beneath the alleyway and a limited stretch of culvert, long enough to convey flow beneath the field entrance may be appropriate. Beyond that, the course of the pipe is believed to pass through the woodland, where the channel would be located. A pipe may be appropriate for the final section, beneath the school margin.

- 1) Create a flood alleviation channel of adequate proportions along the entire western flank of the village, to convey runoff from The Willows to Luston Brook.
- 2) Replace the existing pipe with an open channel, mitigating the risk of blockage and allowing inspection and removal of any material that does accumulate.

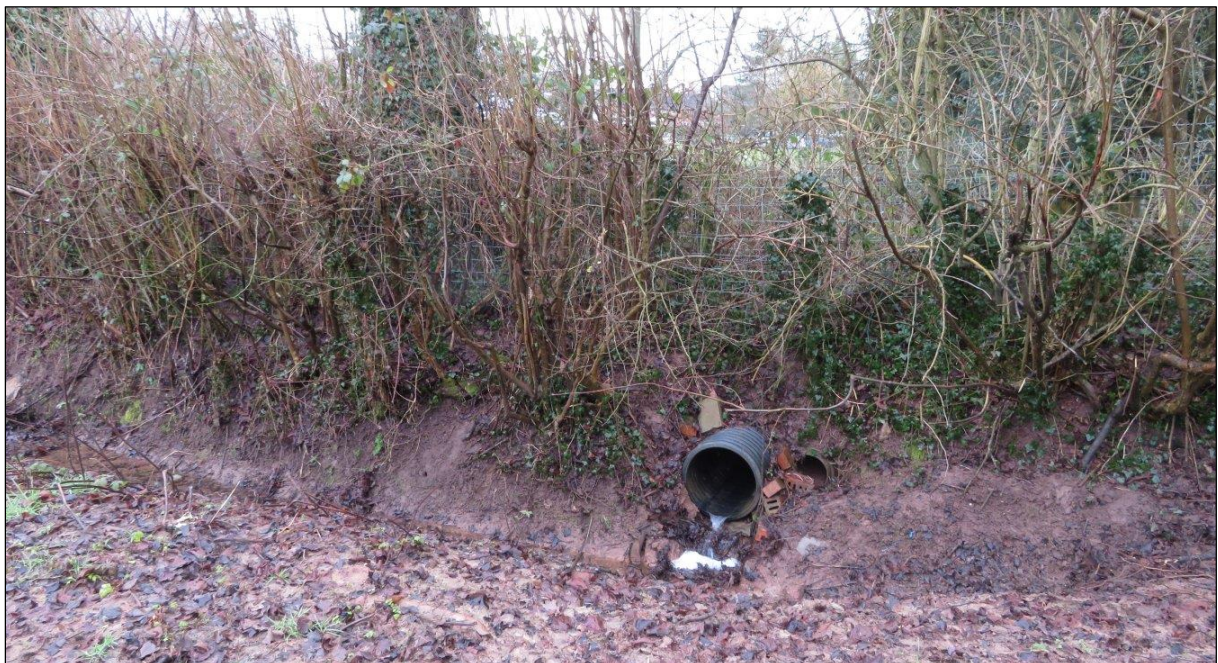
Figure 29 Pipe discharging into a ditch leading to Luston Brook, January 2021

The exact route is not known but the downstream end of this pipe is about 80 m to the north west, where it discharges into a ditch, leading to Luston Brook (Figure 29). Although this pipe provides a route that can divert water away from the school, it is also able to block and, since it is very difficult to inspect, may already contain significant detritus that impedes flow. One witness informed us that the trash screen had trapped significant vegetation during the February 2020 event and may have contributed to flooding at the school.

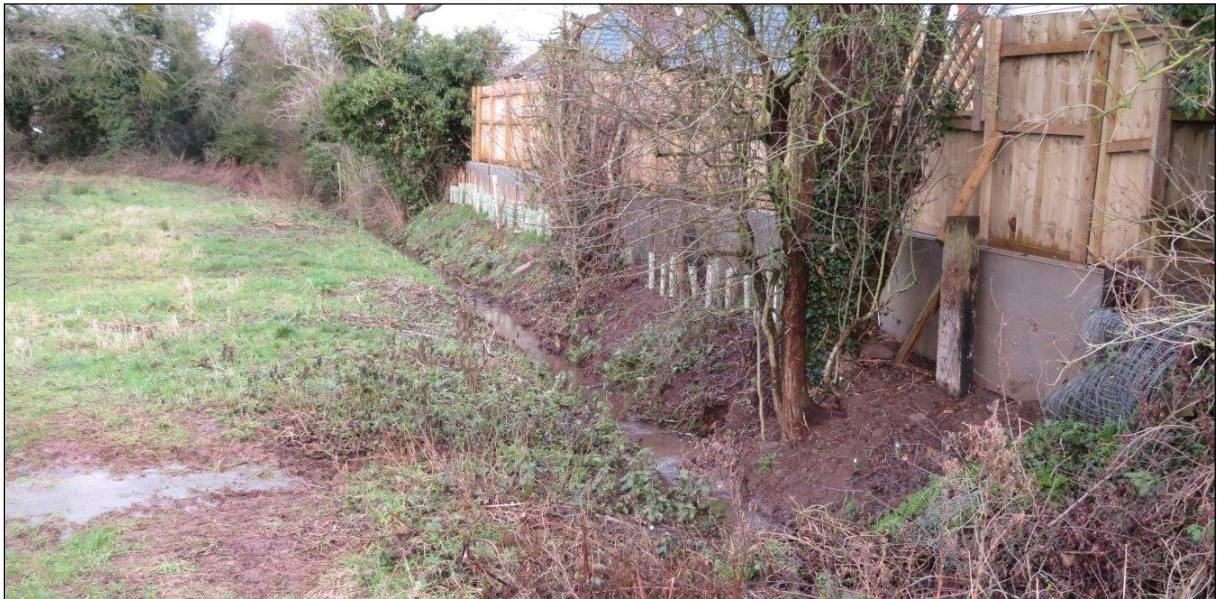
Figure 31 Fed from the north and west, a ditch flows past the west of Mortimer Meadow

The map of surface water flood extent (Figure 24) shows a second route from the south, which is diverted into the houses bounding Westland View. Once again, information provided in the map (Figure 24) differs in detail from the evidence on the ground. When visited, in January 2021, a ditch was conveying water along the western margin of the recent estate of houses known as Mortimer Meadow and located in Figure 30. This flow was augmented by at least one small ditch, flowing from the west (Figure 31).

The structures created to manage flood risk on the western margin of Mortimer Meadow are worthy of comment. It can be seen from Figure 31 that a concrete wall has been established, rising about 1 m above ground level. A line of trees has been planted at the base of that wall and outside the curtilage of the development. It is envisaged that in due course, a network of roots will develop, which will help to stabilise the bank and the wall above it, providing a measure of protection against erosion and / or collapse of the bank, by the flood alleviation channel at its base.

A down-side of the flood alleviation measures already in place west of Mortimer Meadow (Figure 31) and upstream, bounding The Willows (Figure 36, Figure 37 and described in the next Section), is that any flow captured by these channels will be routed along the section of footpath shown in Figure 32 and into the gardens to the south of Westland View (Figure 33). Measures put in place to mitigate surface water flood risk to the south may be having the unintended consequence of increasing it in another part of the village.

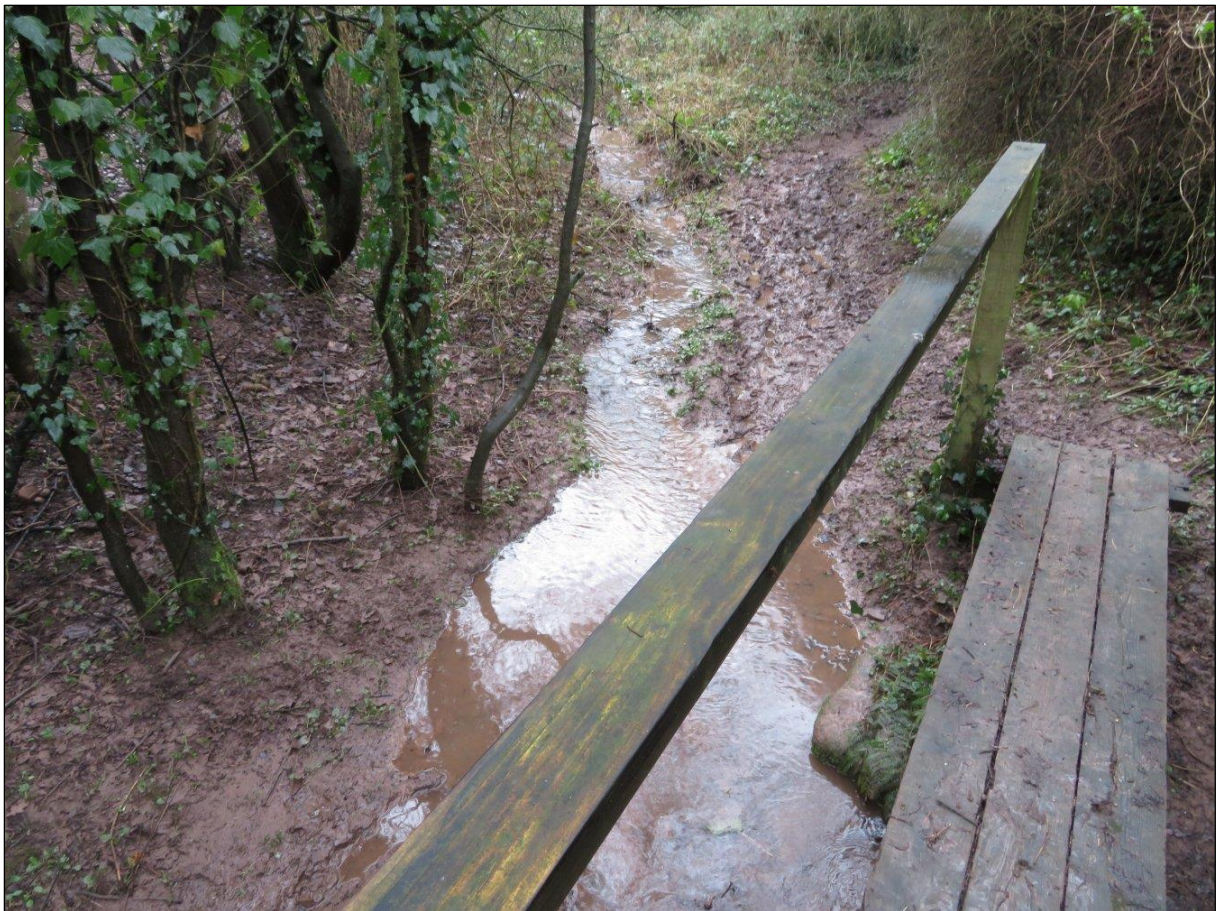
Figure 32 Joining the footpath, the ditch takes a path beneath a wooden footbridge

On reaching the footpath the northward-flowing ditch in Figure 31 is diverted along the footpath for a short distance (Figure 32), before turning back towards the north, into an area of gardens to the south of Westland View (Figure 33). These gardens were not readily accessible and flow could not be traced through them. The surface water flood extent map however (Figure 24) suggests that floodwater would flow between these houses, which suggests that some of them could be affected by flooding.

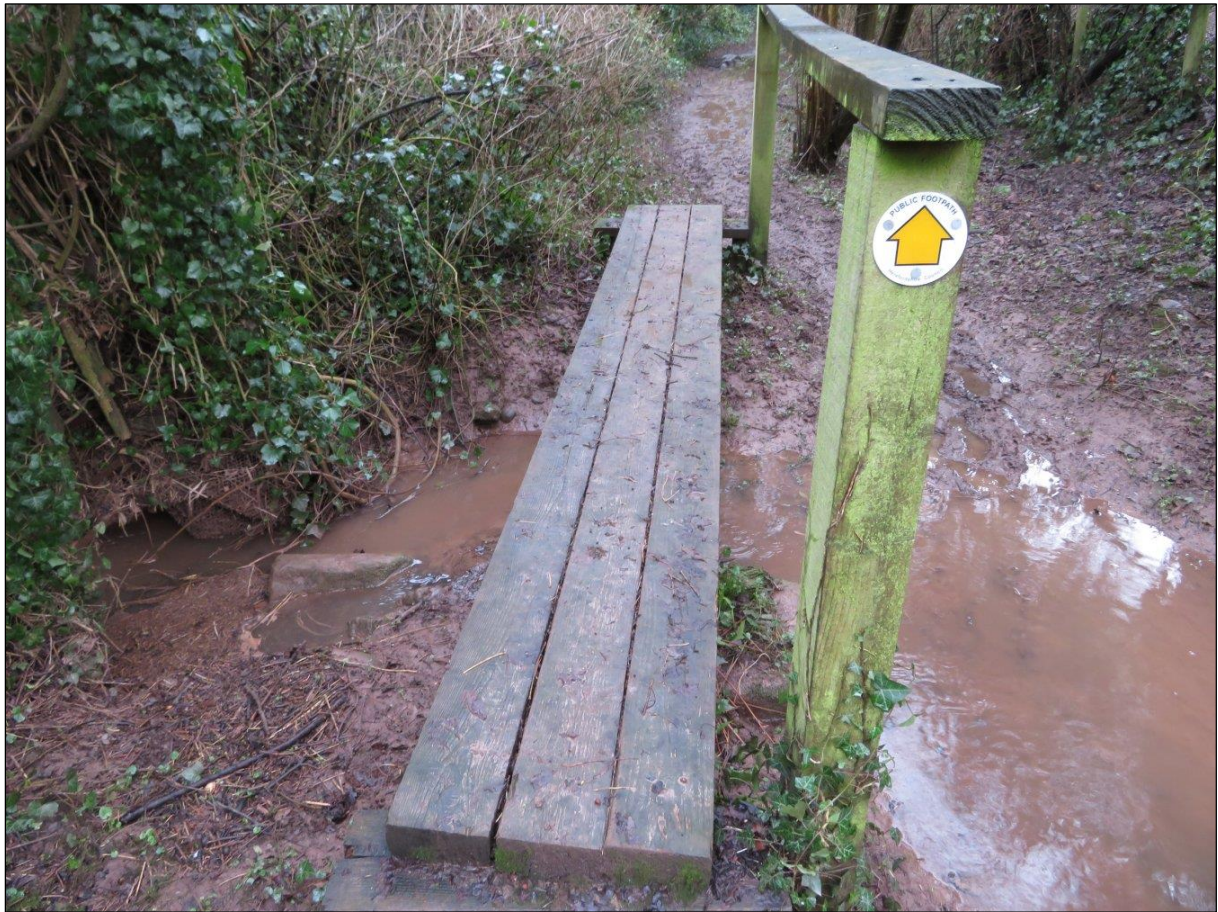
Figure 33 Flow leaves the footpath, flowing into private gardens to the north

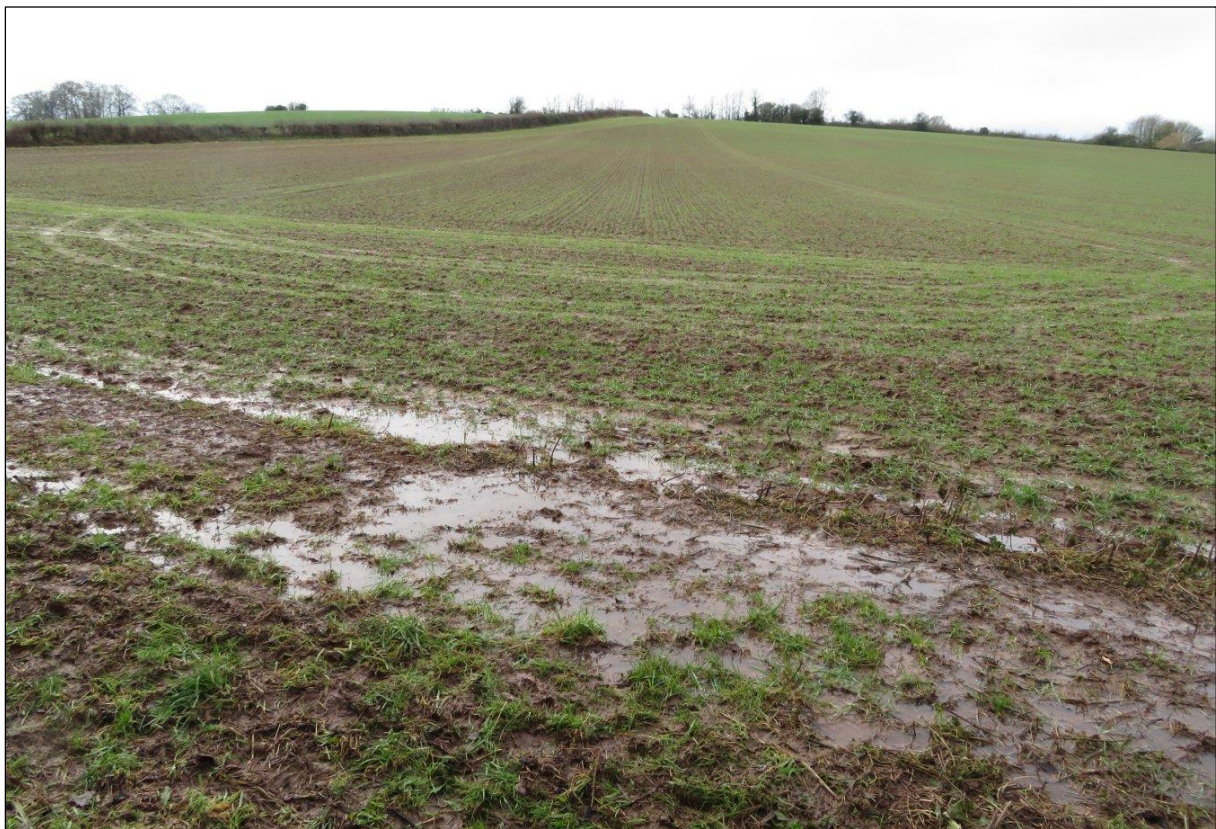
Figure 35 Catchment draining to The Willows, open agricultural land to the west

The source of flood risk at The Willows is clear to see (Figure 35), it is the agricultural land to the west. During the site visit, a resident approached to offer his assistance, he explained that flooding had been problematic in the past but the land owner of the catchment to the west had been approached. Although he was not able to dig the ditch himself, he did give permission for a local man, who had access to a mechanical digger, to create the ditch that can be seen across the field margin, bounding the gardens in Figure 36.

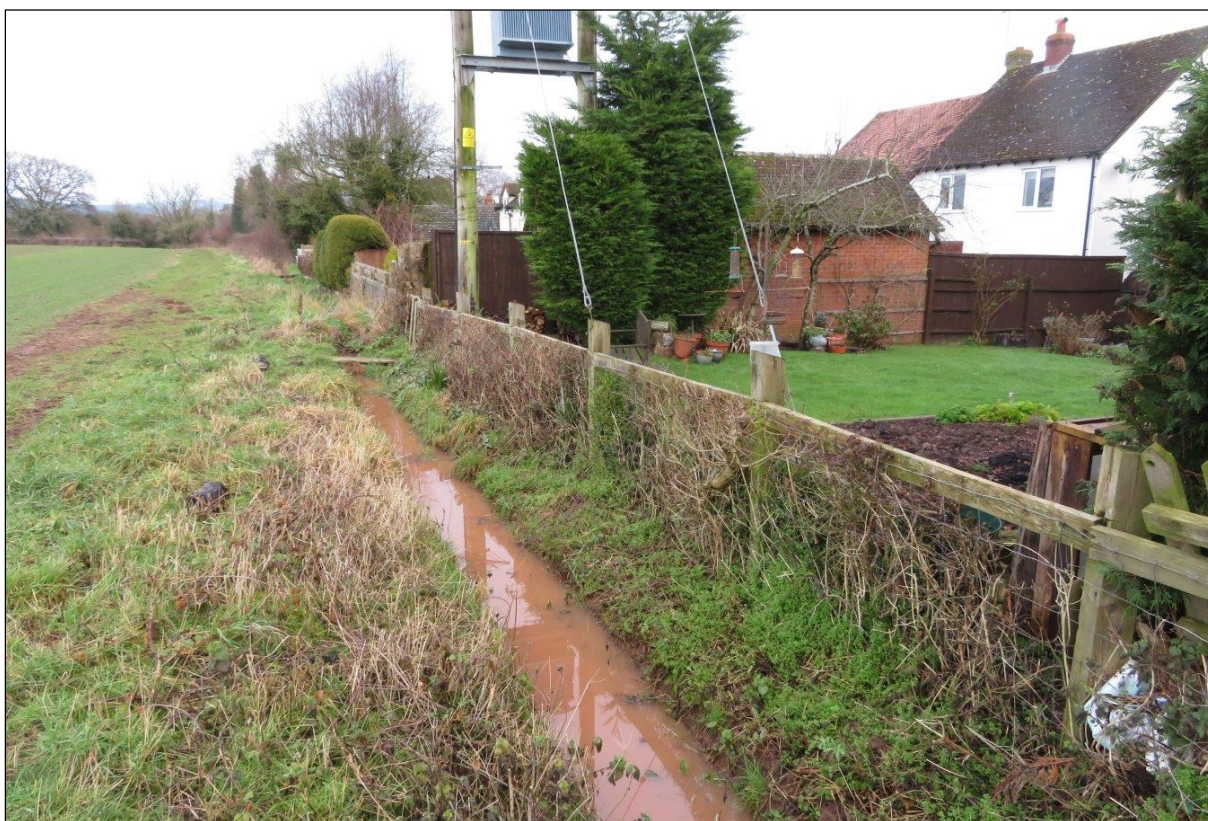
Figure 37 A section of The Willows' ditch, almost at bank-full in January 2021

This section of the ditch was seen to be conveying shallow water and a short distance to the north, this same ditch could be seen to be approaching bank-full. The reason for this could be seen in Figure 36 and an enlarged photo (Figure 37), where partial collapse of the ditch margin has created an element of blockage.

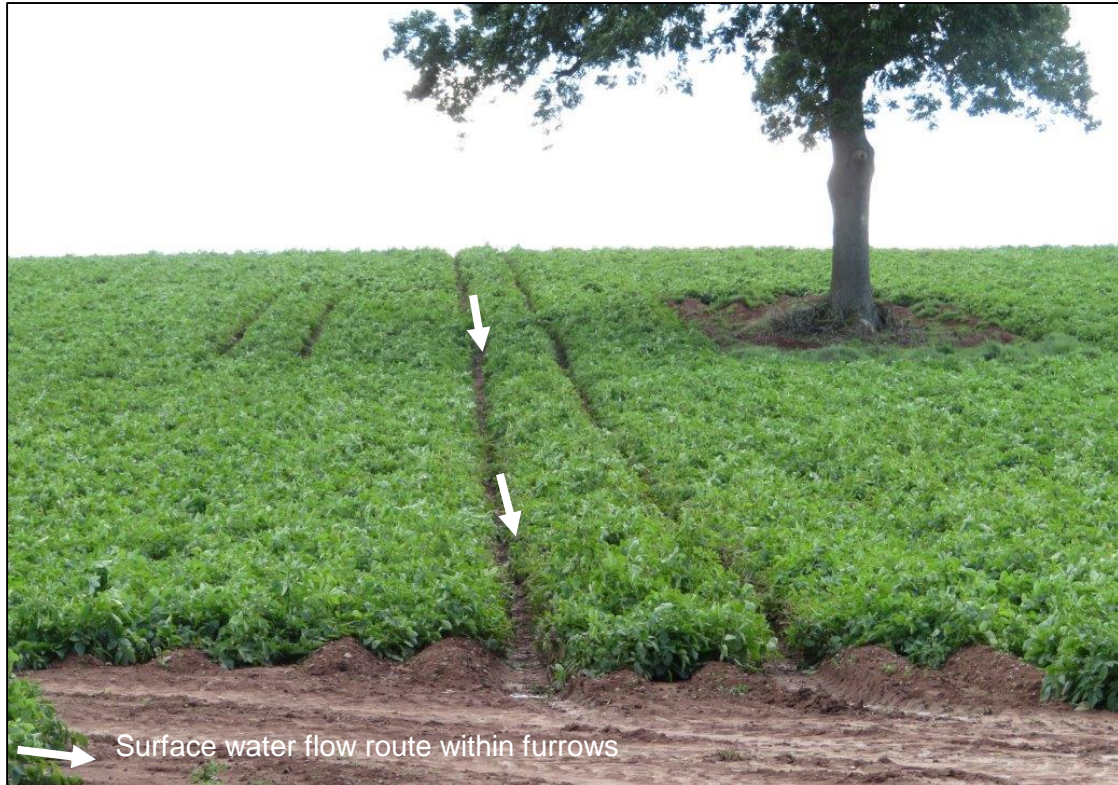
Figure 40 Local land management observed in August 2020

During a site visit, in August 2020, it was observed that the surface of local fields had been ploughed with ridges and intervening furrows, aligned approximately east to west. During a flood event, this form of land management would allow the furrows to act as conduits along which floodwater would flow. In order to manage this risk, soil cultivation should align with the contours, rather than up and down field slopes. This method has been found to slow, store and filter water so that they act as barriers to the down-hill movement of floodwaters. It was observed that this method had been used in local fields, seen during a site visit in October 2021.
